MEMORANDUM

DATE: November 19, 2018

RE: Hinsdale School Culvert and Flooding
Winsted, CT

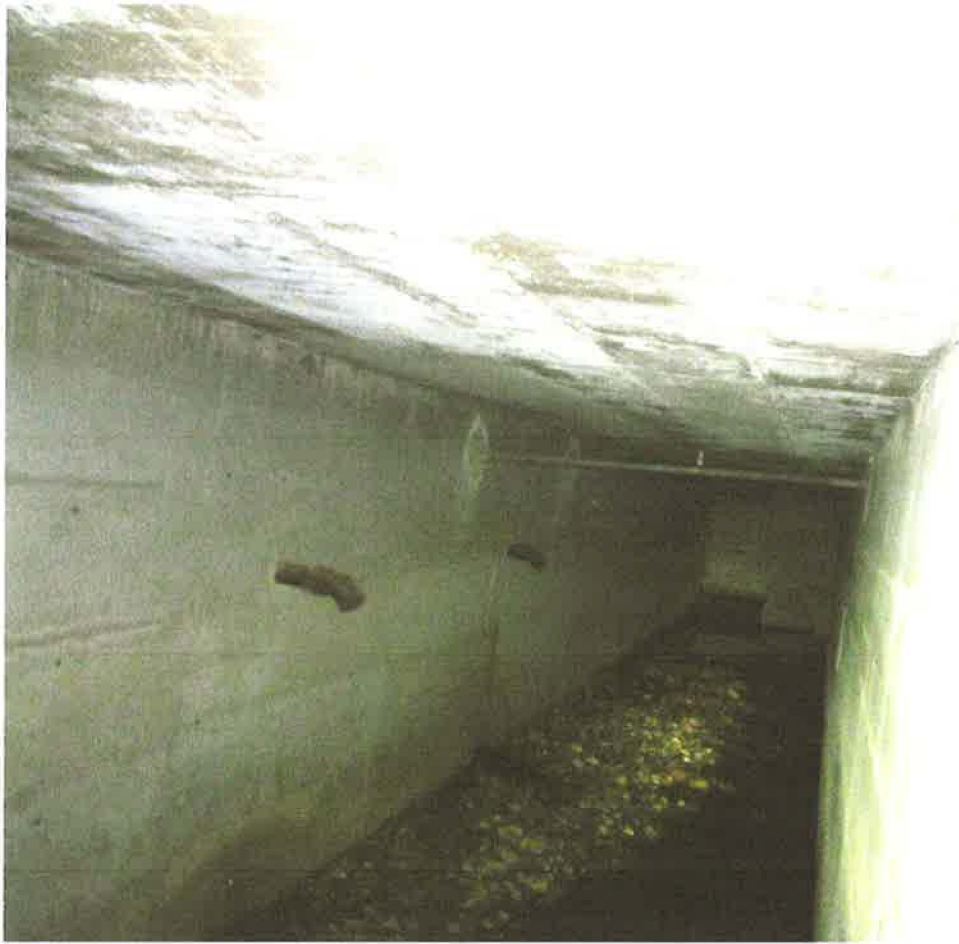
Culvert looking upstream

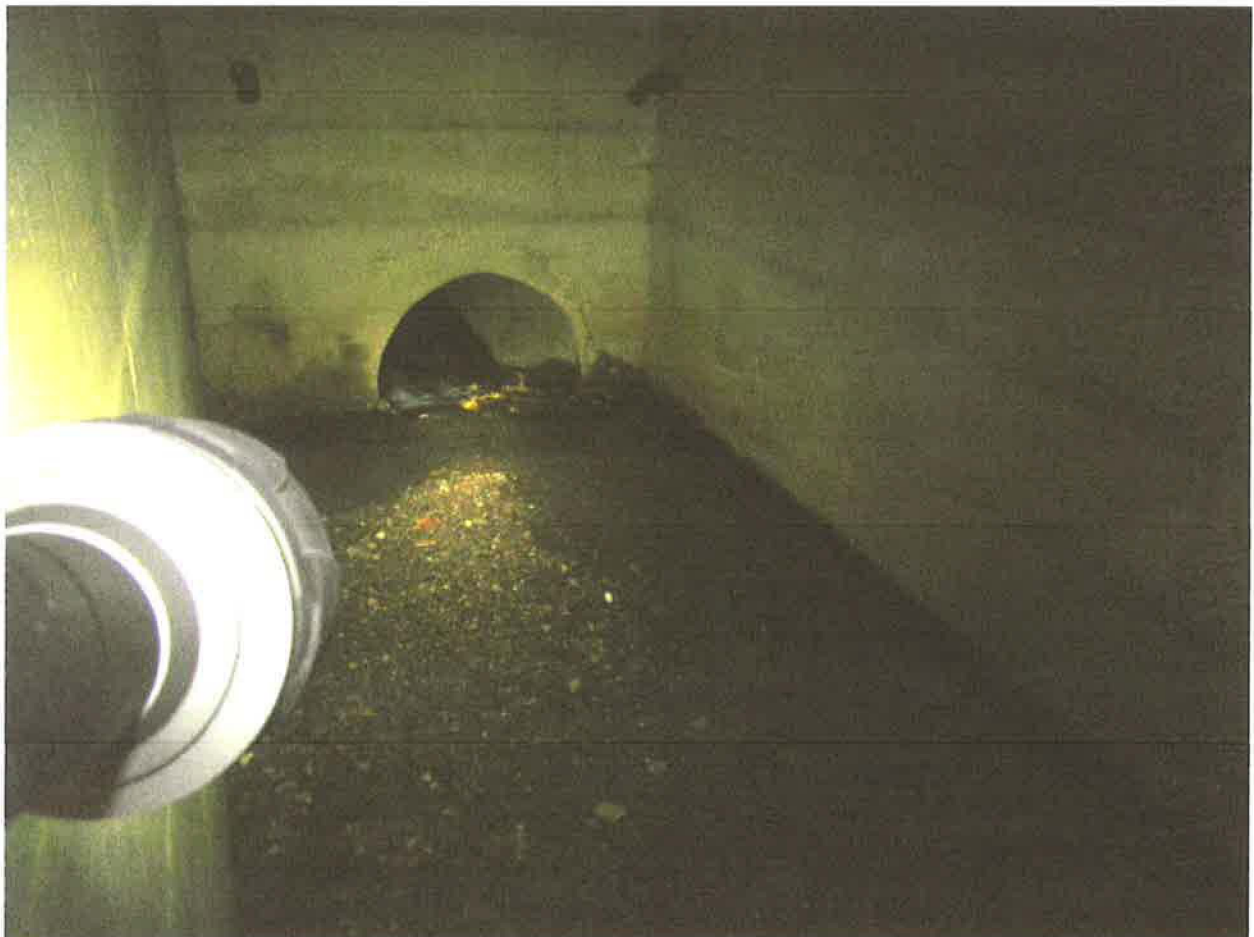
Culvert looking downstream

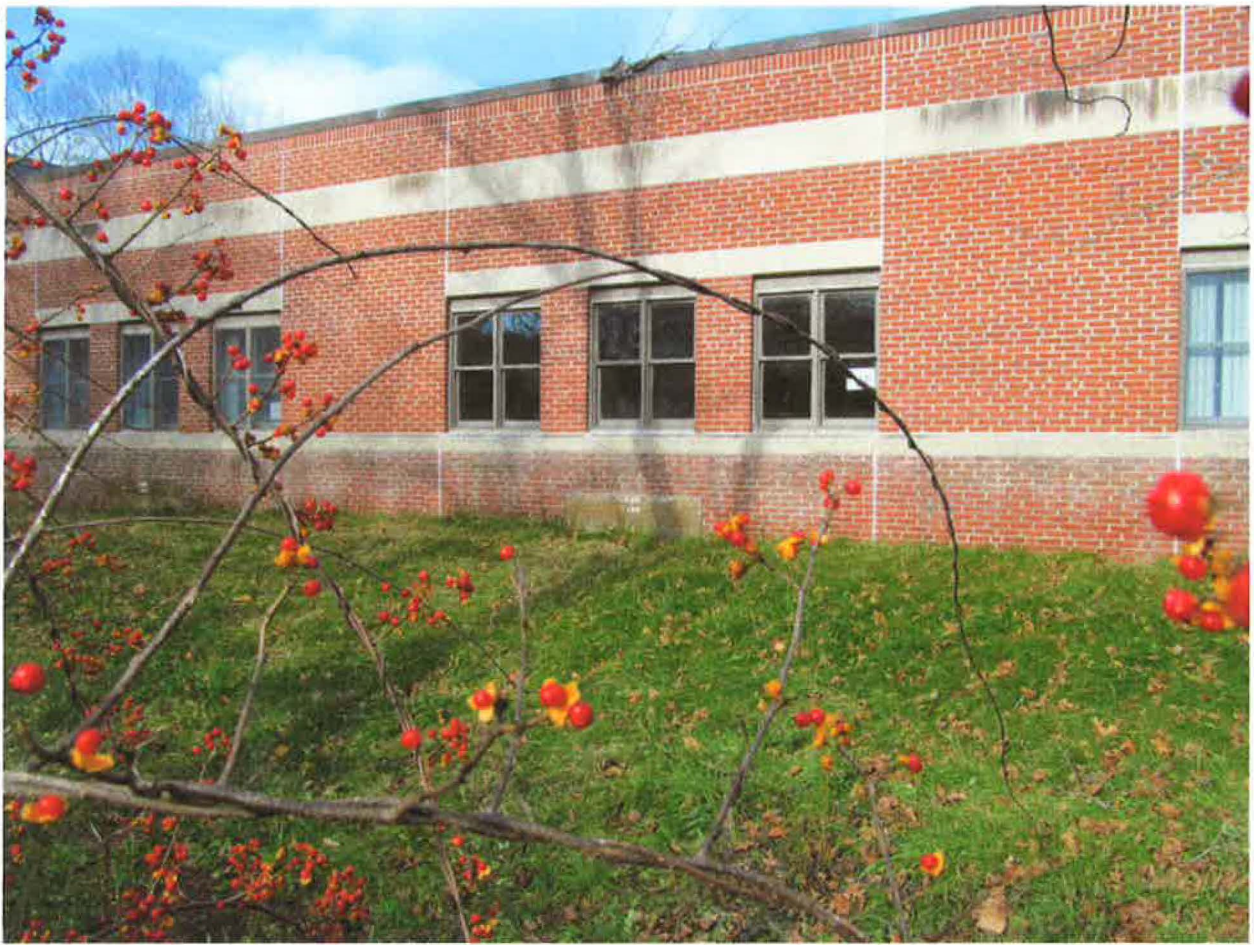
- A field review of the area around the above CB reveled plywood flood covers on the unit ventilators to rooms 105, 106 &107 and the presence of lead shields for bolting covers onto other ventilators in this same area.

Flood boards at room 106 & 107

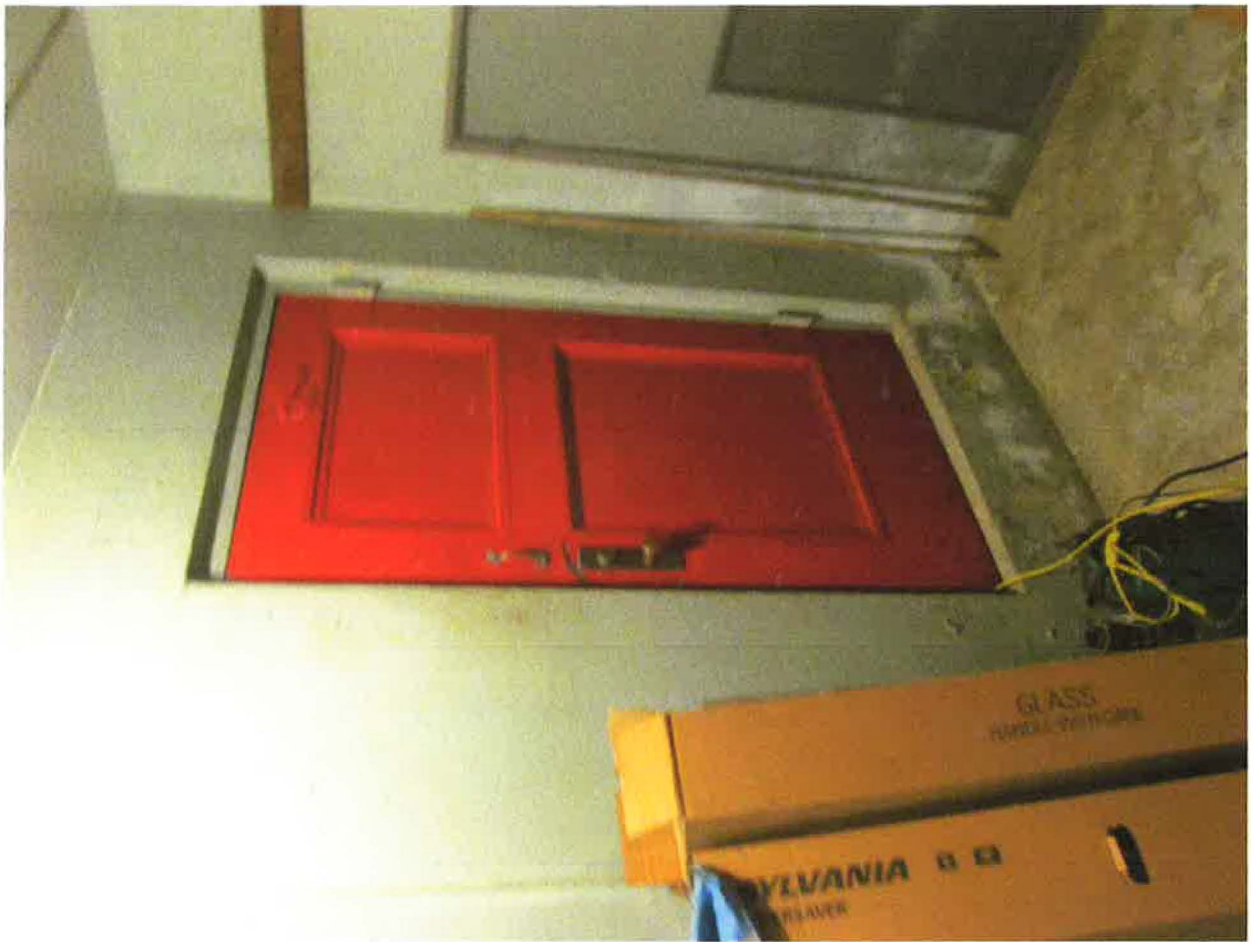
outer door to culvert

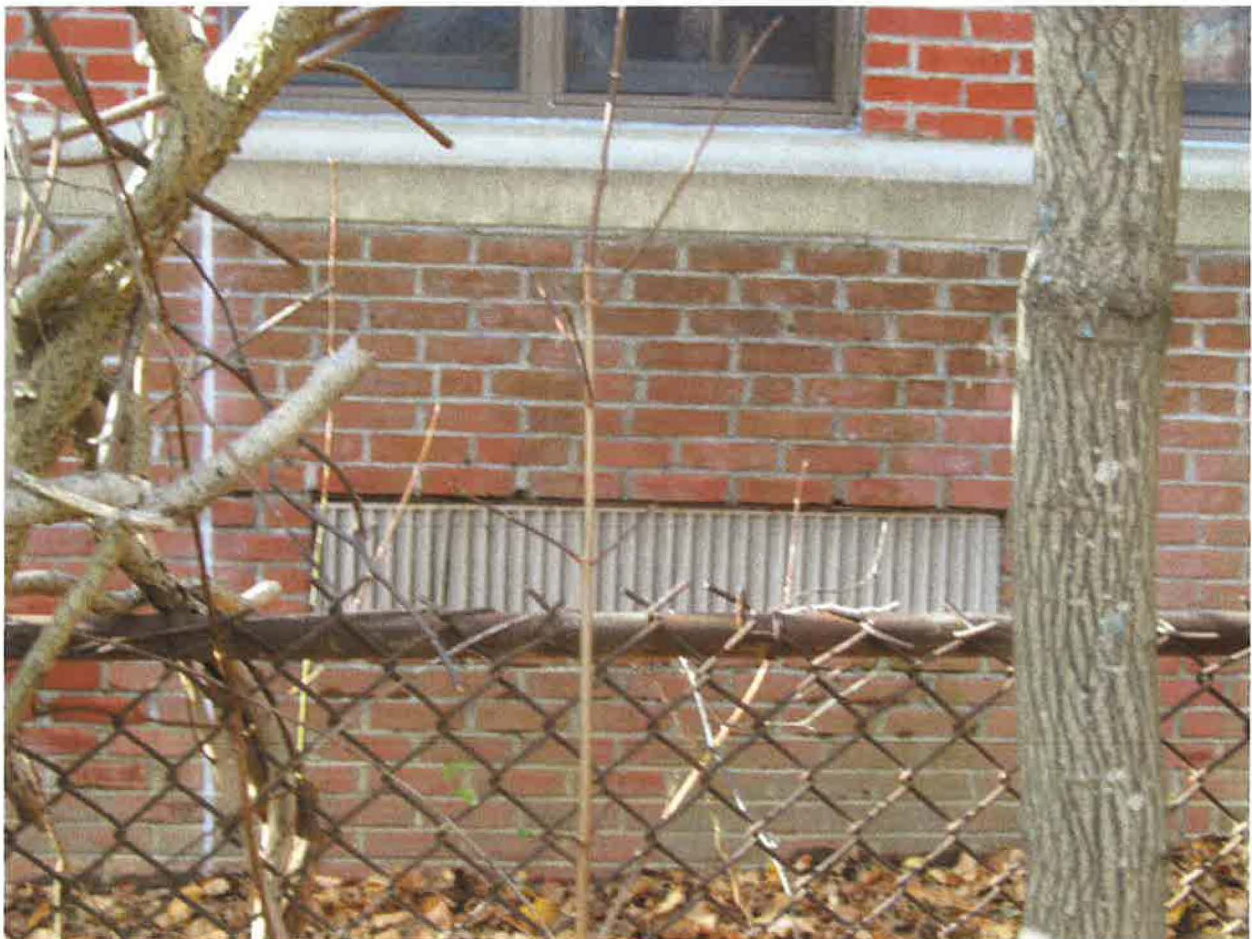
Note lead sleeves at perimeter for bolting flood boards

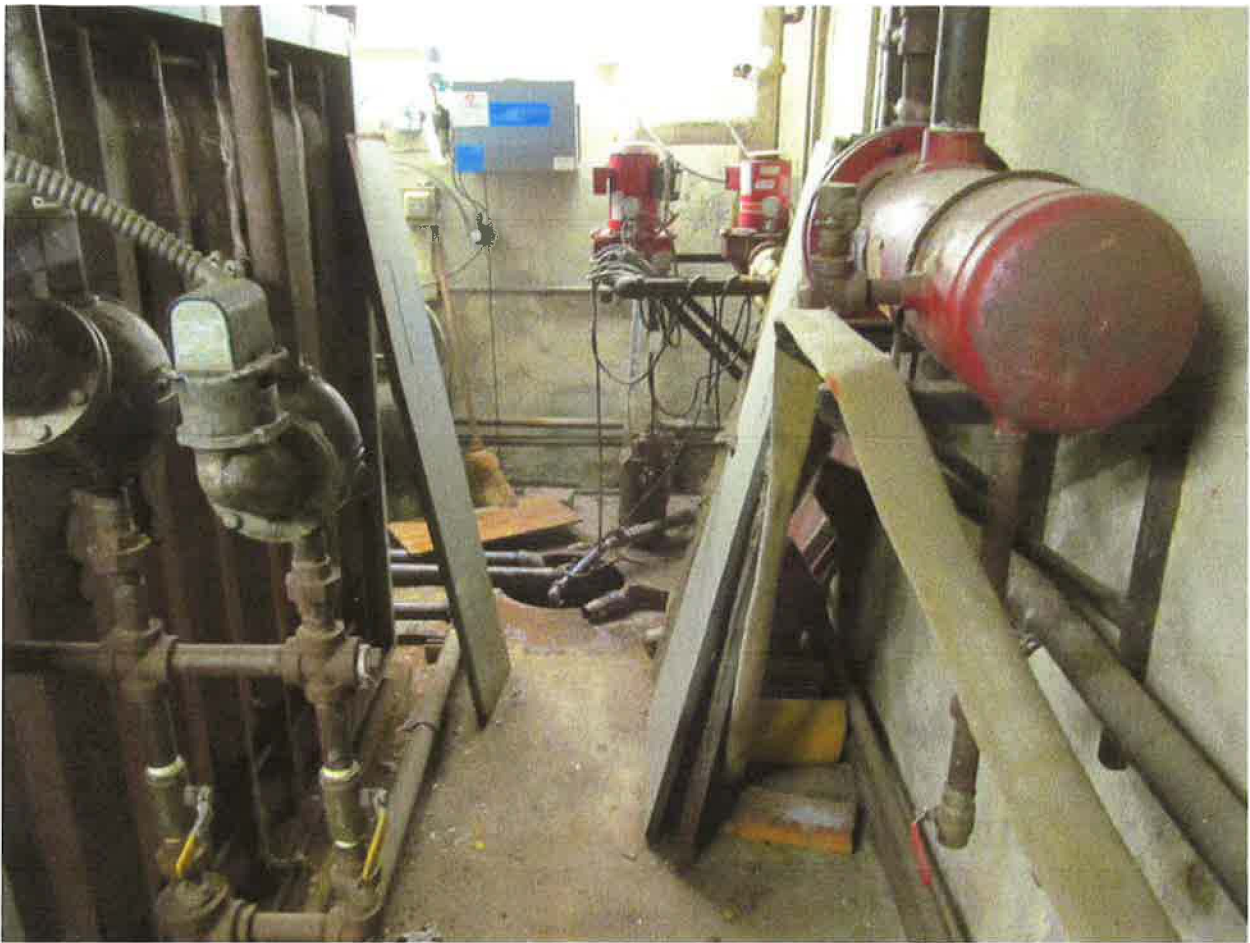
Boiler room sump pump - small pump for normal operations
